Technical Bulletin 56

BMFL Beam Exposure Protection

Version 1.0.0

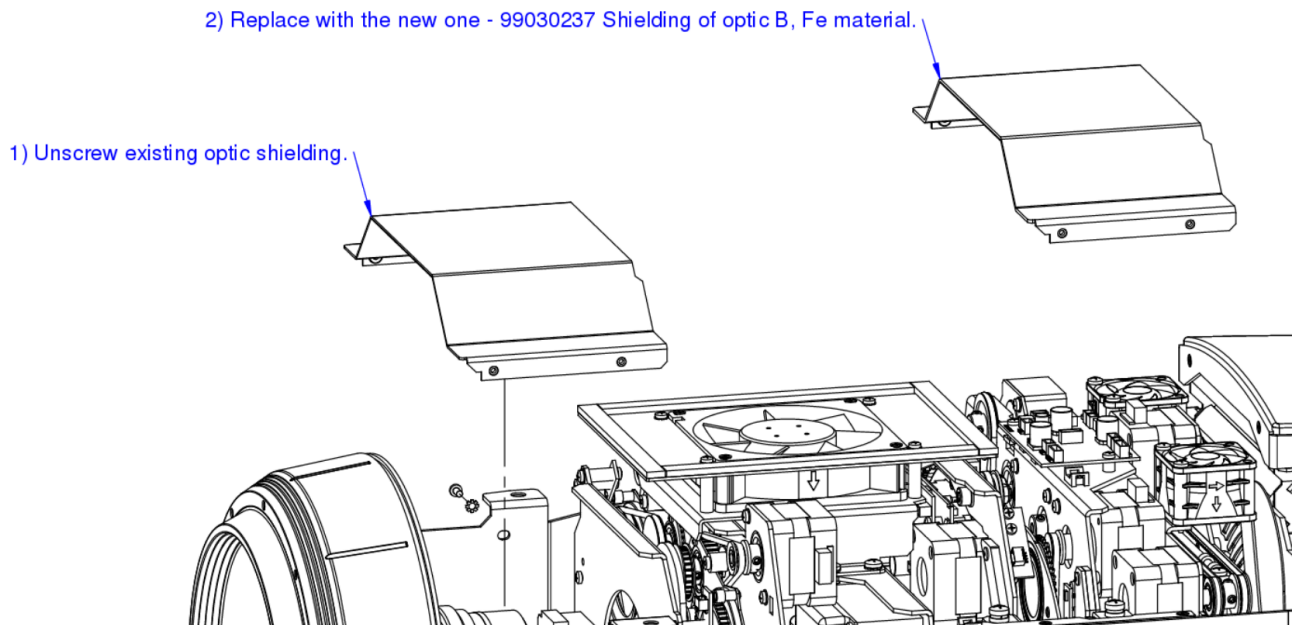
Besides software update, the Robin BMFL Blade as the only fixture required hardware modification to keep the head correctly tilting down when powered down. For the rest of the BMFL series only software update is needed.

The internal metal cover on the BMFL Blade is now made of thicker material to ensure correct front weight. This change was introduced starting from serial **1600550392**. Ordering code for this cover is **99030237**.
